## **DEPARTMENT OF TRANSPORTATION**

### **EXPERIMENTAL CONSTRUCTION REPORT 99-11**

#### **INNOVATIVE SOLUTIONS to BURIED PORTLAND CEMENT CONCRETE ROADWAYS**

##### **SECOND INTERIM**

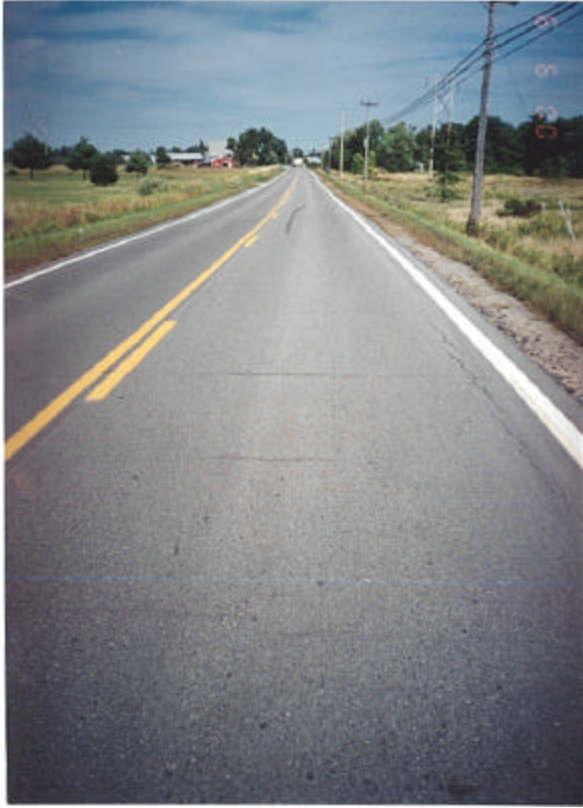
Rutting was observed throughout this section. Thirty-two percent had rut depths of less than 6 mm (0.25 in), 64% had rut depths between 6 and 13 mm (0.25 and 0.5 in), and 4% was over 19 mm (0.75 in) in depth caused by a truck traveling on un-compacted mix during paving operations.

Transverse cracking has increased considerably since last year's evaluation and 85.7% of the section has PCC related edge cracking, an increase of 36.2 %. Typical cracking patterns are exhibited in the Section 0 (Control) photo.

Rutting and transverse cracking has increased considerably in Section 0 (Control). Shoulder deflections and the amount of PCC edge cracking has also increased. This Section has very little pavement support beyond the PCC supported roadway and is not recommended as a shoulder treatment for composite roads.

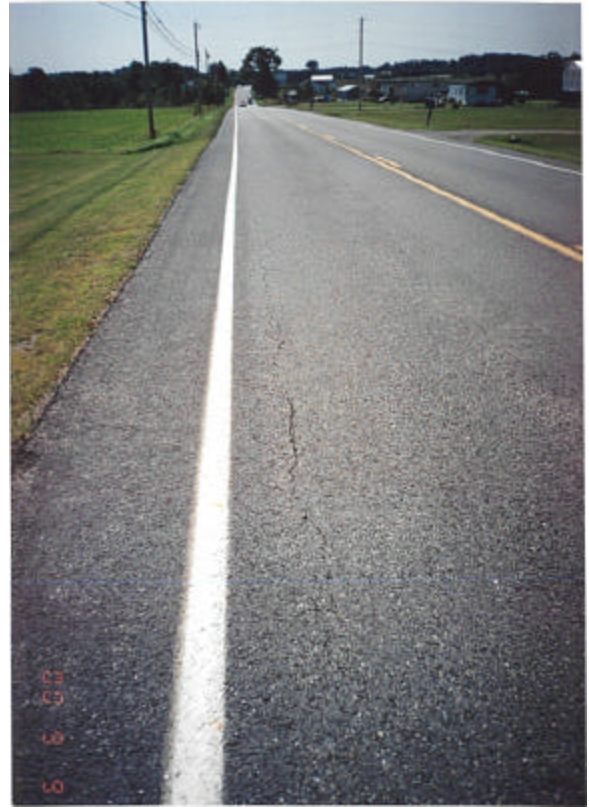
PCC related edge cracking was evident on 25.3% of the section with no change in shoulder elevation (see Section 2A photo). This is the highest amount of PCC related edge cracking within the experimental sections.

Section 2A using 230 mm of Flowable Fill has the highest shoulder deflections of the four reconstructed shoulders. This section also has increased rutting and transverse cracking as well as the largest amount of PCC edge cracking (with the exception of Section 0). Although this application is supporting the shoulder, it is also showing signs of deterioration more so than the other treatments. Future evaluations will determine if this shoulder treatment should be used.

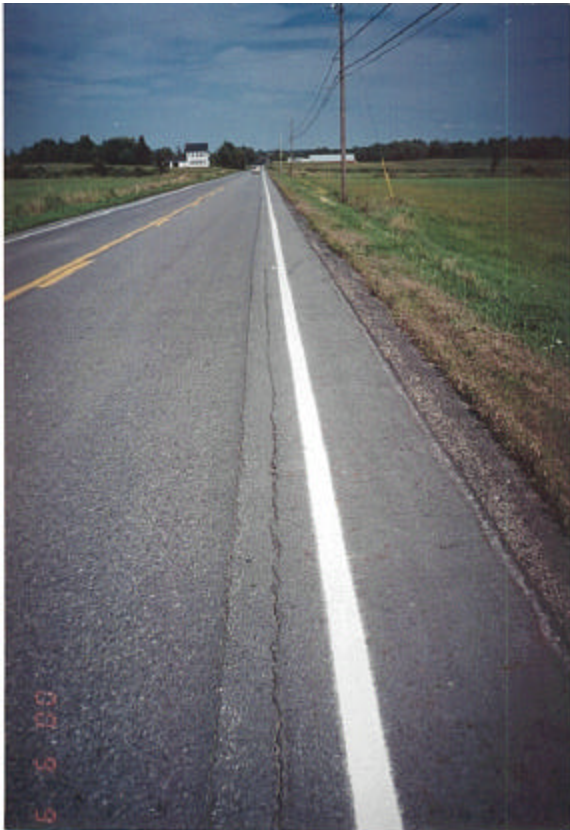
The longitudinal shoulder construction joint 3 m (10 ft) left and right of centerline has separated from the roadway throughout 93.2% of this section (see Section 3 photo).

There were no transverse cracks but there was an increase in PCC related cracking from 10.7% to 14.5% (see Section 3 photo) and shoulder elevation has increased from 6 mm (0.25 in) to 13 mm (0.5 in).

Section 3 (Superpave) has a large amount of PCC related edge cracking, an increase in rutting, and shoulder elevation has increased from 6 mm (0.25 in) to 13 mm (0.5 in). However, pavement deflections are the lowest of all sections. Although edge cracking has increased, the increase is very small indicating this treatment may be stabilizing. Edge cracking could also be caused by the unusual construction procedure (mentioned earlier). Future evaluations may verify the stability of this treatment. Even though this treatment has the highest cost, the low deflections and small increase in edge cracking indicates this treatment may be used as a shoulder treatment for composite roads.

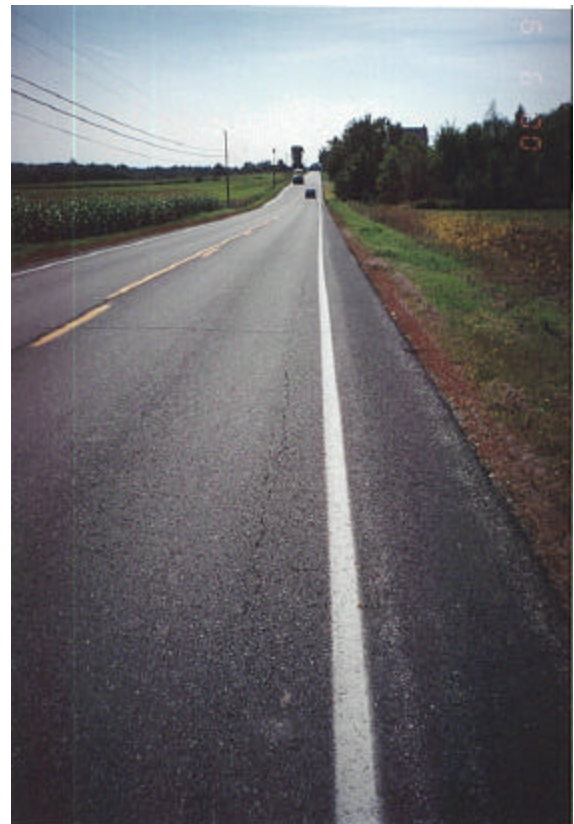
PCC related edge cracking has increased from 0.4 to 14.6% with no elevation change (see Section 4 photo).

Section 4 (Heavy Overlay) shoulder deflections are very high, in fact they are only 12% lower than Section 0 shoulder deflections. However, PCC edge cracking is less severe than Section 2A using Flowable Fill. Rutting has not increased but the number of transverse cracks has. This is expected since Section 4 was not milled before resurfacing, allowing reflective cracking of the surface mix. Since there is little edge cracking and the shoulder condition is good this treatment is performing well after two years. Future evaluations will determine if this treatment should be used as a shoulder treatment for composite roads.

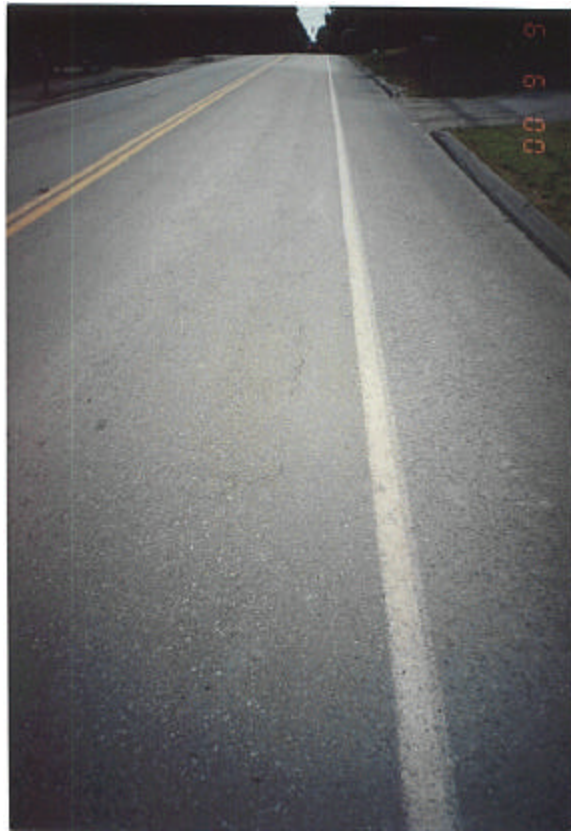
Self Adhesive Mesh (Veazie Project)

This section is performing very well. Rutting, joint condition, transverse cracking and PCC edge cracking has not changed since last year (see Self Adhesive Mesh photo).

The Self Adhesive Mesh combined with recycled pavement has reduced the amount of edge cracking in this Section. Future evaluations of this application will determine if this can be used on composite roads.

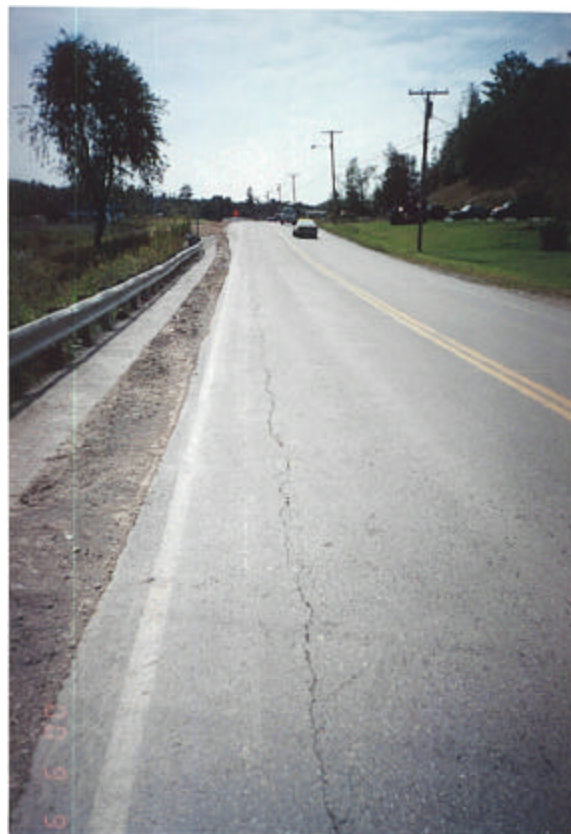
## Control Section (Veazie Project)

PCC related cracking has increased from 28% to 30.6% and shoulder elevation has dropped 10 mm (0.4 in) possibly due to utility construction (see Control Section photo).

The Control Section experienced a 2.6% increase in edge cracking from last year and an elevation change of 10 mm (0.4 in). Utility construction in this section could be contributing to the increased edge cracking. Although there is an increase in edge cracking and rutting, the section is appears to be performing well.
